B737 NG

AVIONICS FLAGS / FAULT MESSAGE GUIDE

FOR TRAINING USE ONLY
PREPARED BY MAINTENANCE TRAINING

January 2012

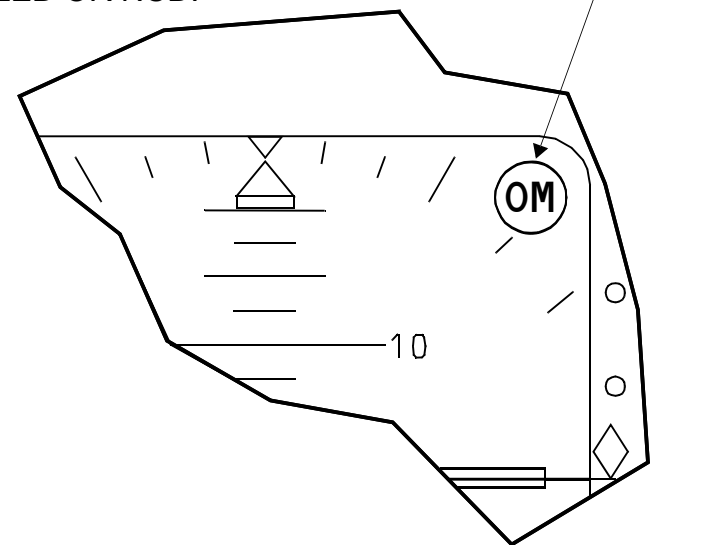
737 NG - MARKER BEACON WILL NOT DISPLAY

If the Marker Beacon data fails or is no computed data (NCD), the display does not display on both the Captain and F/O AI display.

MARKER BEACON INDICATION IS REMOVED WHEN FAILED OR NCD.

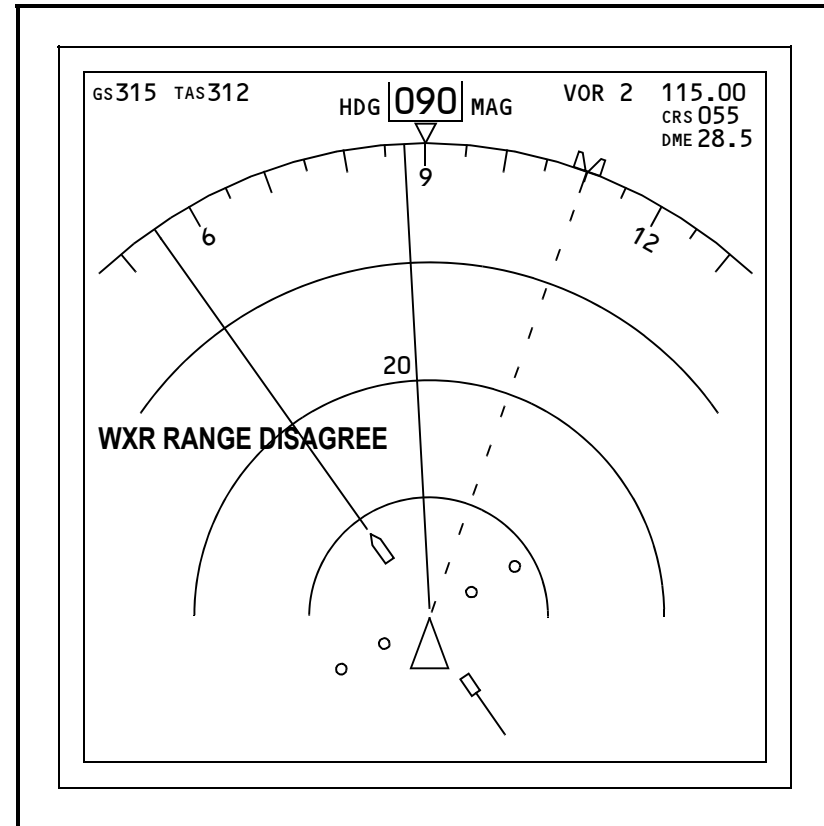
737 NG - WXR RANGE DISAGREE - MESSAGE

WXR RANGE DISAGREE Message

- EFIS Control Panel
- Weather Radar Transceiver
- DEU
- Wiring
