# B737 NG

## AVIONICS FLAGS / FAULT MESSAGE GUIDE

FOR TRAINING USE ONLY  
PREPARED BY MAINTENANCE TRAINING

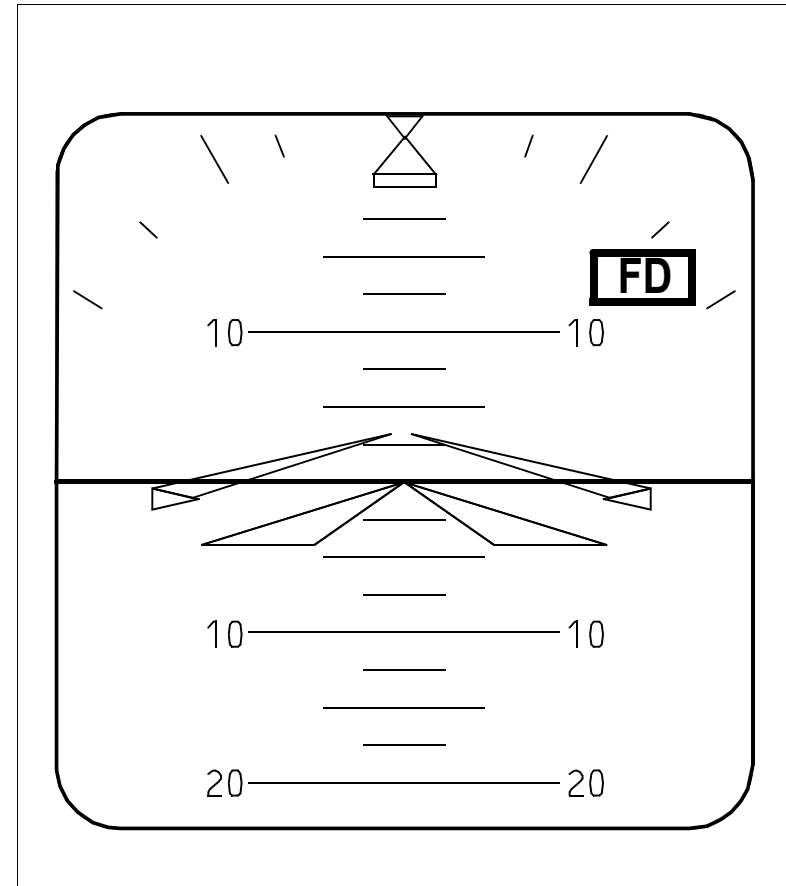
The Amber Flight Director (FD) Flag shows when the on-side flight director function of the Flight Control Computer (FCC) has Failed.

### Flight Director Flag Possible Causes

- Flight Control Computer (FCC)

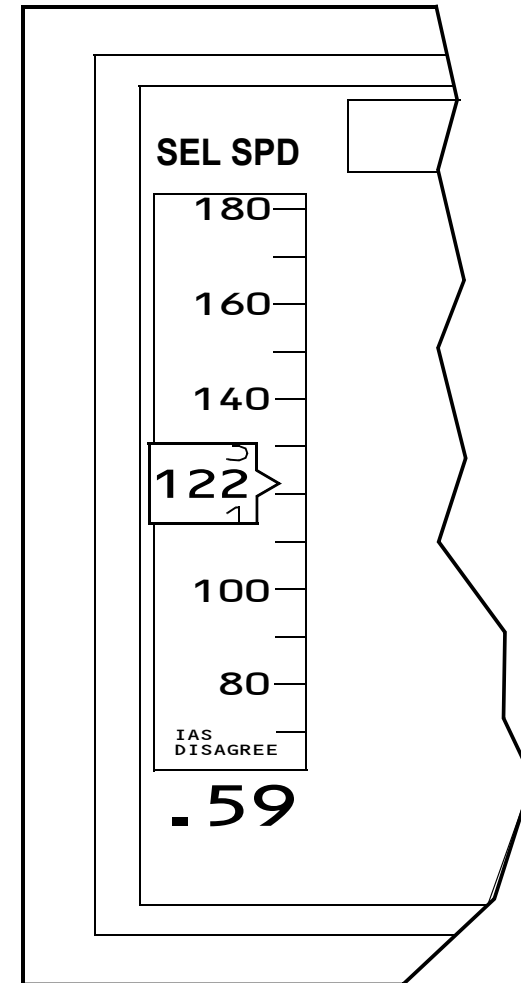
737 NG - SELECTED SPEED - FLAG

When the MCP selected target airspeed is invalid, an amber SEL SPD message shows above the Mach Airspeed Indicator MASI.

If the SEL SPD flag shows on one side only, replace the on-side FCC.

Replace the MCP if the SEL SPD flag appears on both the Captain and F/O airspeed indicator.

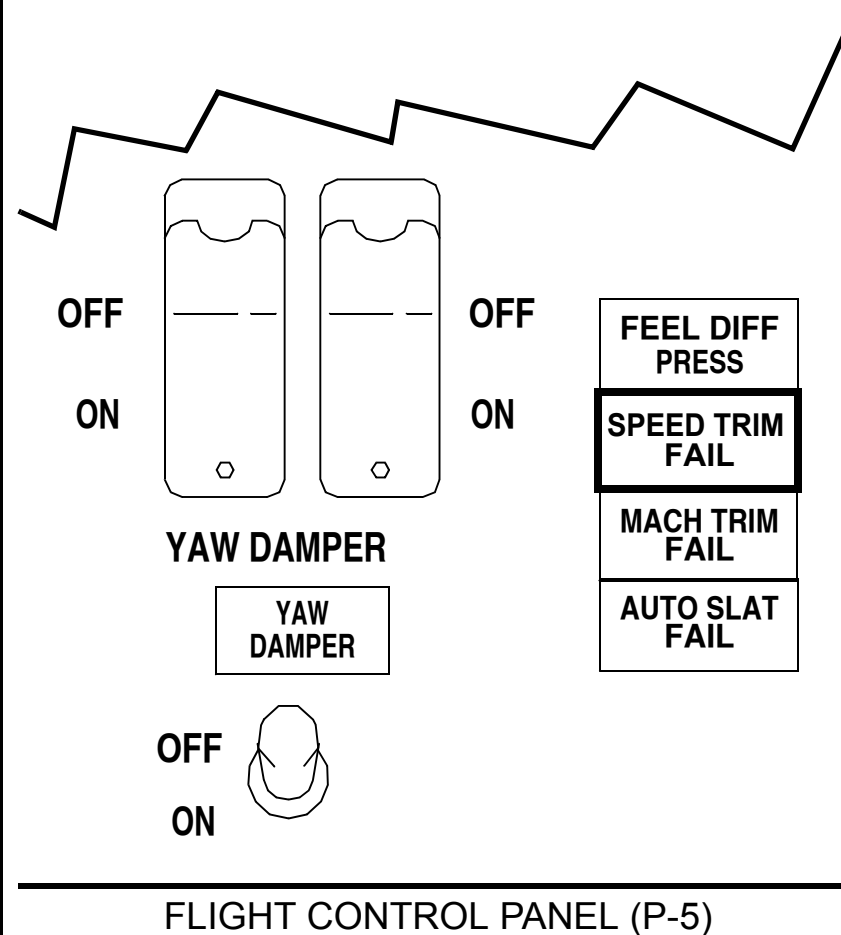
737 NG - SPEED TRIM FAIL - LIGHT

## Single Channel Speed Trim Fail Light

If a single channel failure occurred, there is no annunciation until you push the System Status Annunciator panel assembly (recall). When you push the annunciator panel, these annunciations show:

## Dual Channel Speed Trim Fail Light

If dual channel failure occurred, these annunciations show:

- SPEED TRIM light on
- FLT CONT light on the System Status Annunciator
- Left and right Master Caution lights

When you push and release either the left or right Master Caution light, the FLT CONT light and Master Caution lights go out but the SPEED TRIM light stays on.

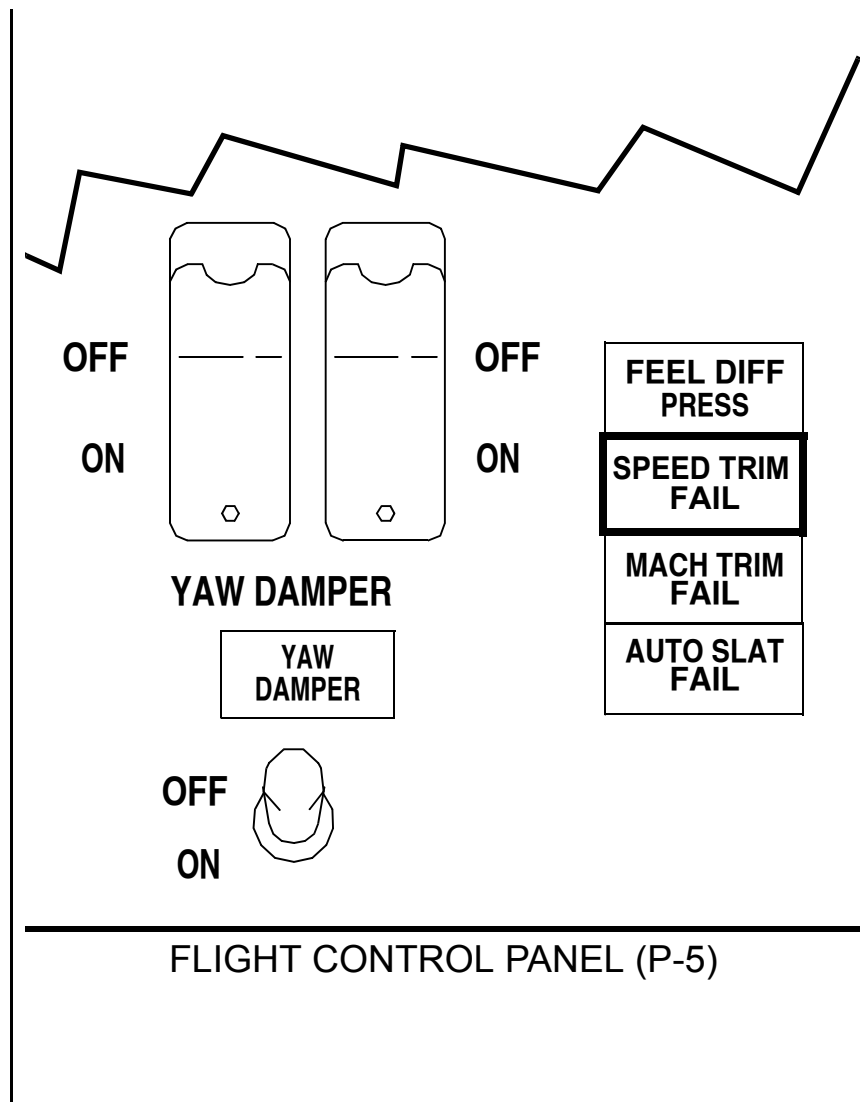
737 NG - SPEED TRIM FAIL - LIGHT

## (Dual Channel) Speed Trim Fail Possible Causes

- Stab Trim Electric Motor
- Stab Trim Relay (R384)
- Column Switching Module
- A/P Trim Cutout Switch (S149)
- Flight Control Panel
- Wiring
- Flight Control Computer (FCC)

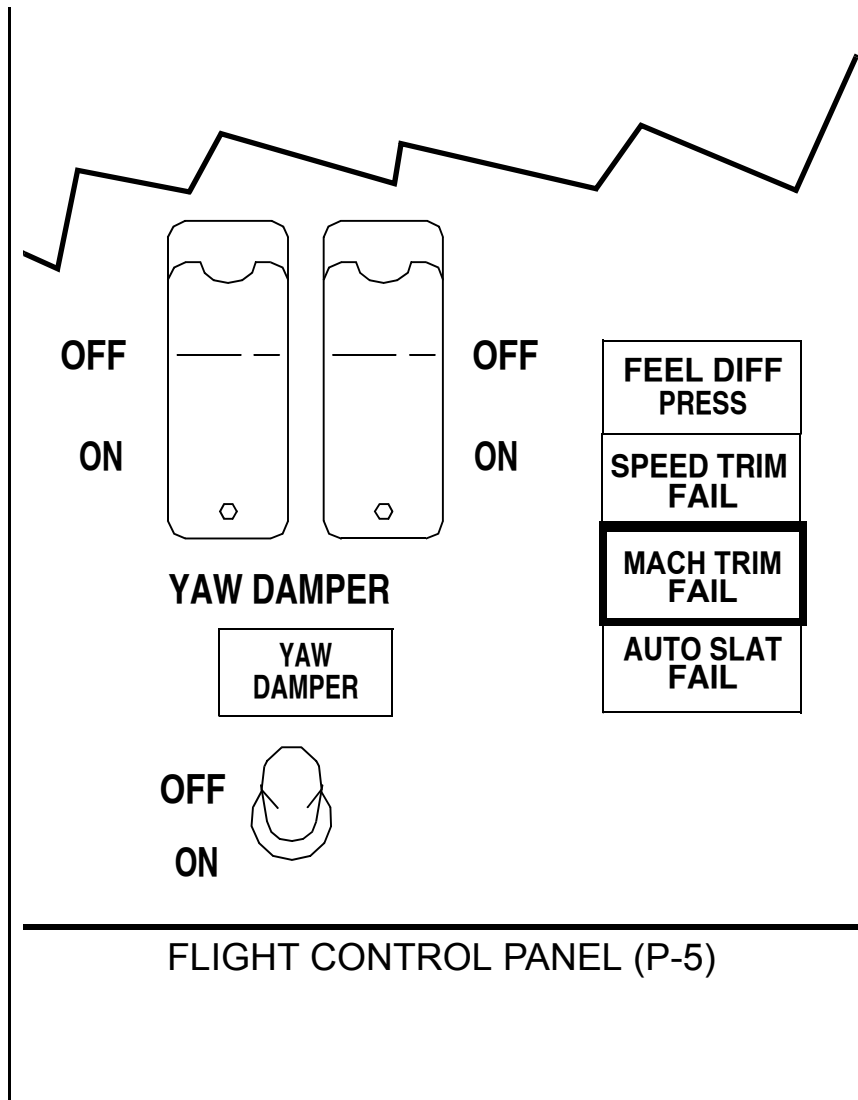
737 NG - MACH TRIM FAIL - LIGHT

## Single Channel Mach Trim Fail Light

If a single channel failure occurred, there is no annunciation until you push the System Status Annunciator panel assembly (recall). When you push the annunciator panel, these annunciations show:

## Dual Channel Mach Trim Fail Light

If dual channel failure occurred, these annunciations show:

- MACH TRIM light on
- FLT CONT light on the System Status Annunciator
- Left and right Master Caution lights

When you push and release either the left or right Master Caution light, the FLT CONT light and Master Caution lights go out but the MACH TRIM light stays on.

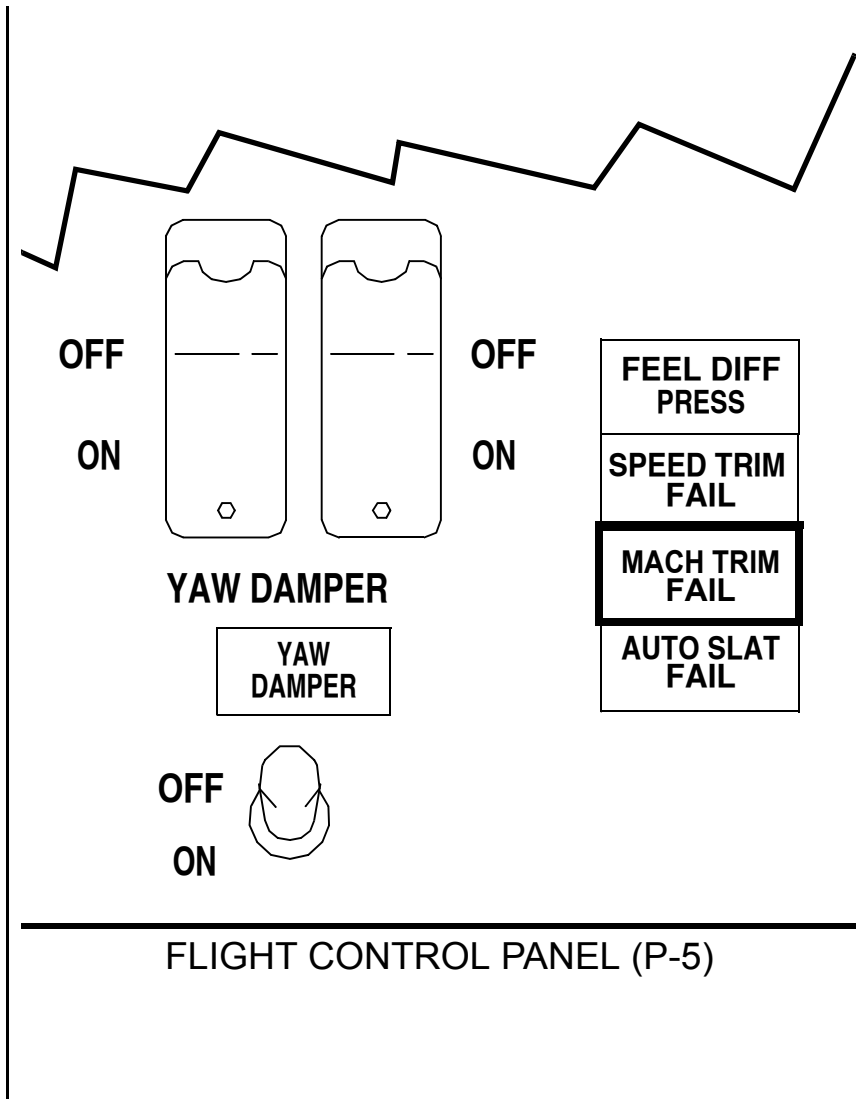
737 NG - MACH TRIM FAIL - LIGHT

## (Dual Channel) MACH Trim Fail Possible Causes

- Mach Trim Actuator
- Integrated Flight System Accessory Unit (IFSAU)
- Flight Control Panel
- Wiring
- Flight Control Computer (FCC)

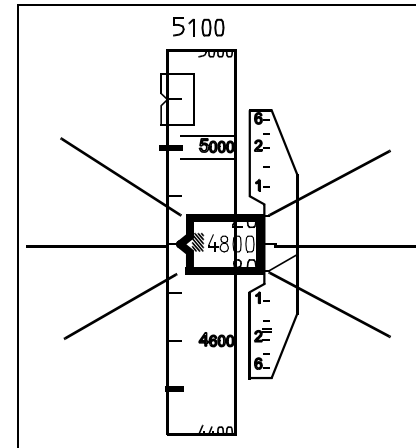
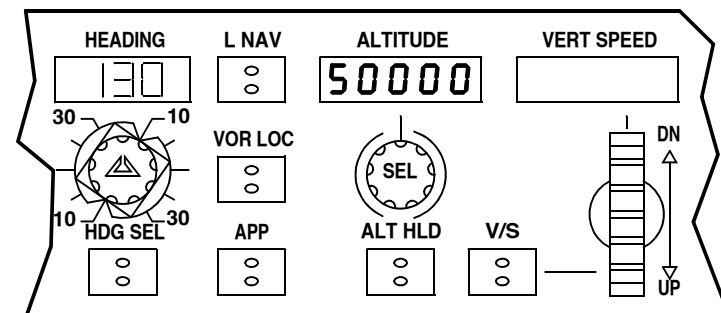
## 737 NG - MODE CONTROL PANEL LOCK-UP - 50,000 FT IN ALTITUDE WINDOW

AURAL  
WARNING

ALTITUDE ALERT FLASHES

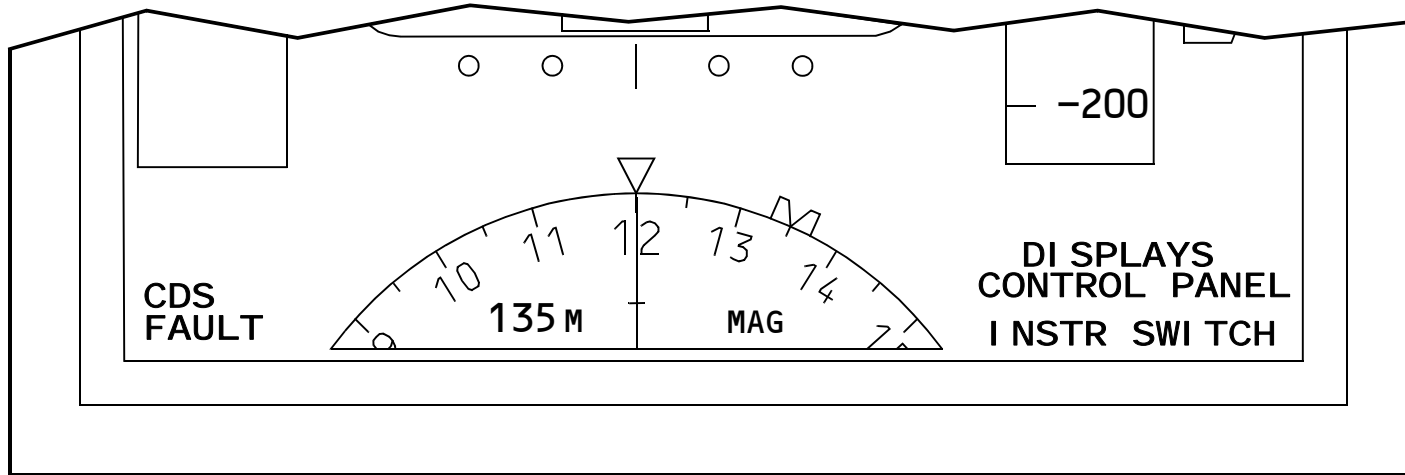
PRIMARY FLIGHT DISPLAY

<b>INSTR SWITCH</b>	INERTIAL REFERENCE DATA FROM SAME SOURCE
<b>CDS MAINT</b>	PARTIAL DEU FAILURE (SHOWS ON THE GROUND WITH AT LEAST ONE ENGINE SHUT OFF)
<b>CDS FAULT</b>	DEU FAILURE OR BOTH DEU(S) HAVE A PARTIAL FAILURE. INCOMPATIBLE S/W OR H/W. MISCOMPARE OF CRITICAL DATA. HOT BATTERY BUS NOT AVAILABLE. DATA LOAD SWITCH IN DEU 1 OR DEU 2 POSITION. (SHOWS ON THE GROUND WITH AT LEAST ONE ENGINE SHUT OFF) FOR HOT BATTERY BUS OR DATA LOAD SWITCH, CDS FAULT IS REMOVED WHEN BOTH ENGINES START. HYD PRESSURE A MISSING = DEU1. HYD PRESSURE B MISSING = DEU2.
<b>DSPLY SOURCE</b>	SHOWS IN THE AIR FOR CDS FAULT OR CDS MAINT. ALSO, SHOWS WHEN ALL ON 1 (2) IS SELECTED.
<b>DISPLAYS CONTROL PANEL</b>	ON-SIDE EFIS CONTROL PANEL FAILURE. THE ALTIMETER INDICATOR ALSO FLAGS WITH AN <b>ALT</b> FLAG, BECAUSE THE ON-SIDE ADIRU LOSES BARO CORRECTION FROM THE EFIS CONTROL PANEL.

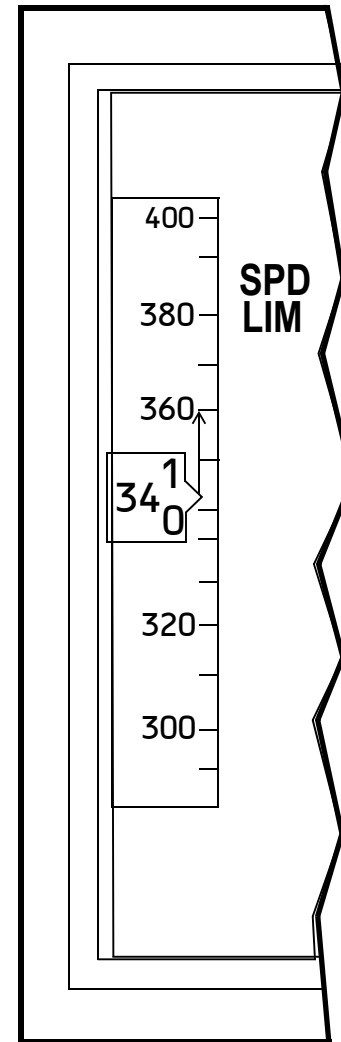
737 NG - SPEED LIMIT - FLAG

## SPD LIM Flag Possible Causes

- Stall Management Yaw Damper Coupler (SYMD)
- Display Electronics Unit (DEU)
- Wiring

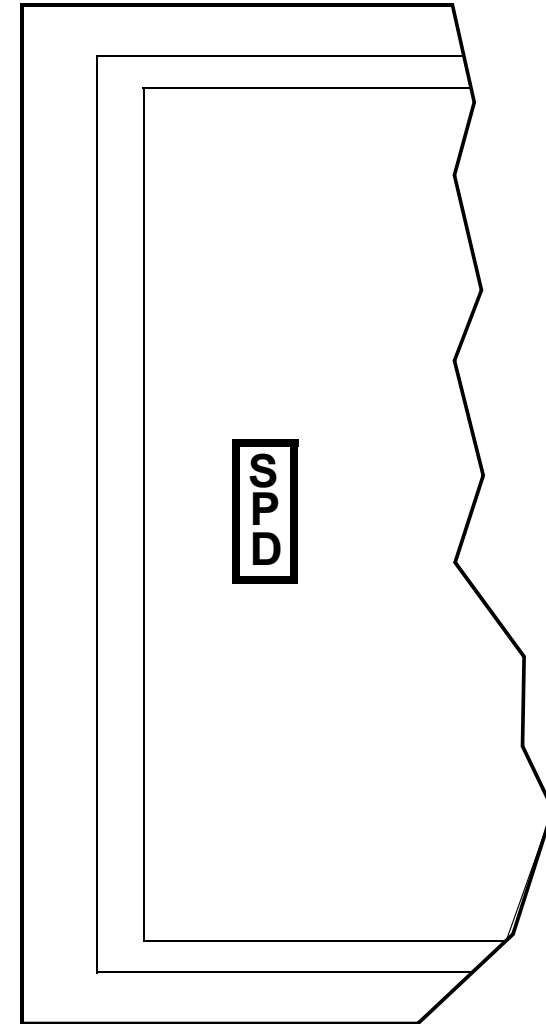
737 NG - AIRSPEED - FLAG

## Airspeed (SPD) Fail Flag

The Amber SPD flag replaces the airspeed indication.

- ADIRU
- DEU
- Pitot Air Data Module (ADM)
- Wiring from ADM to ADIRU
- Wiring from the ADIRU to the DEUs

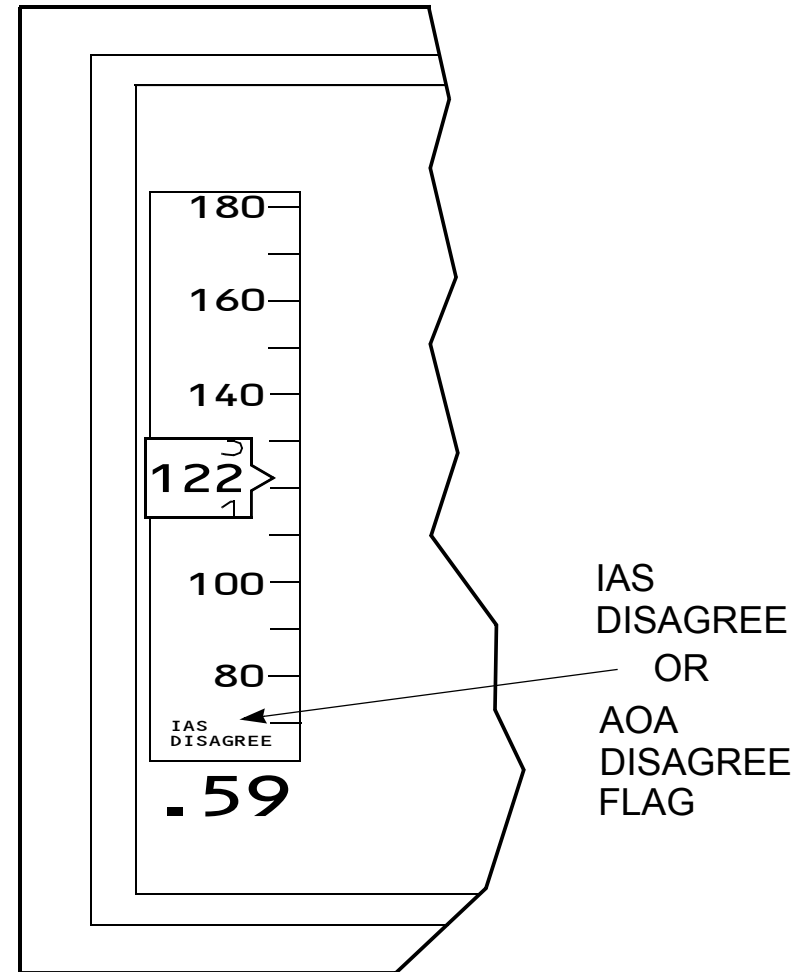
## 737 NG - INDICATED AIRSPEED DISAGREE - FLAG

## IAS DISAGREE Flag Possible Causes

- Pitot source problem (pitot probe / lines leaking)
- Static source problem (static port / lines leaking)

## AOA DISAGREE Flag Possible Causes

AOA sensors position mismatch. Move AOA sensors.

Bad AOA Sensor. Use SMYD BITE.

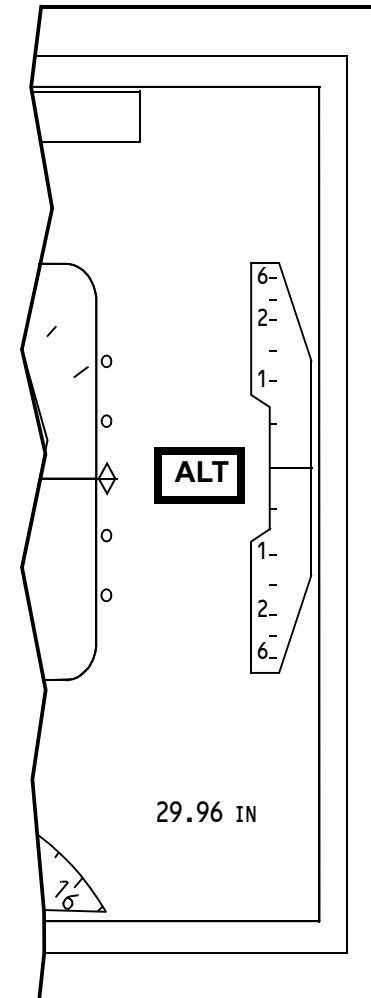
737 NG - ALTIMETER - FLAG

## ALTIMETER (ALT) Fail Flags

The Amber ALT flag replaces the altitude indication. However, baro-correction remains in view.

- ADIRU
- DEU
- Static Air Data Module (ADM)
- Wiring from ADM to ADIRU
- Wiring from the ADIRU to the DEUs

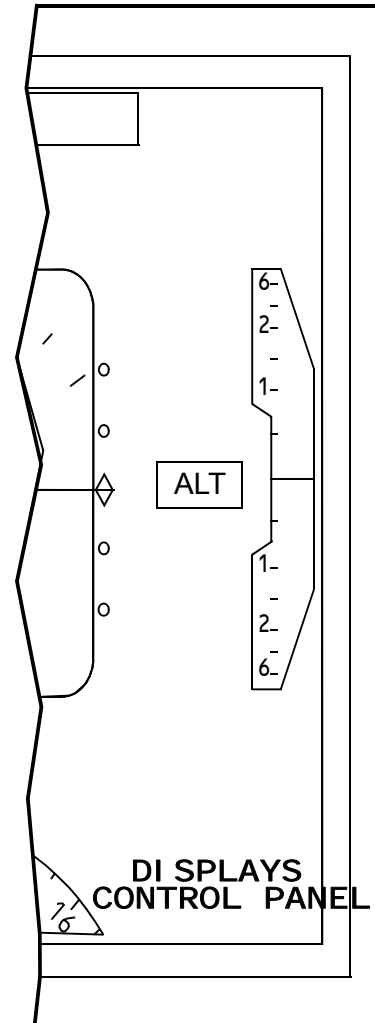
## 737 NG - ALTIMETER AND DISPLAYS CONTROL PANEL- FLAG

The Amber ALT flag replaces the altitude indication, and DISPLAYS CONTROL PANEL is displayed.

- EFIS Control Panel
- DEU
- Wiring from EFIS Control Panel to DEUs

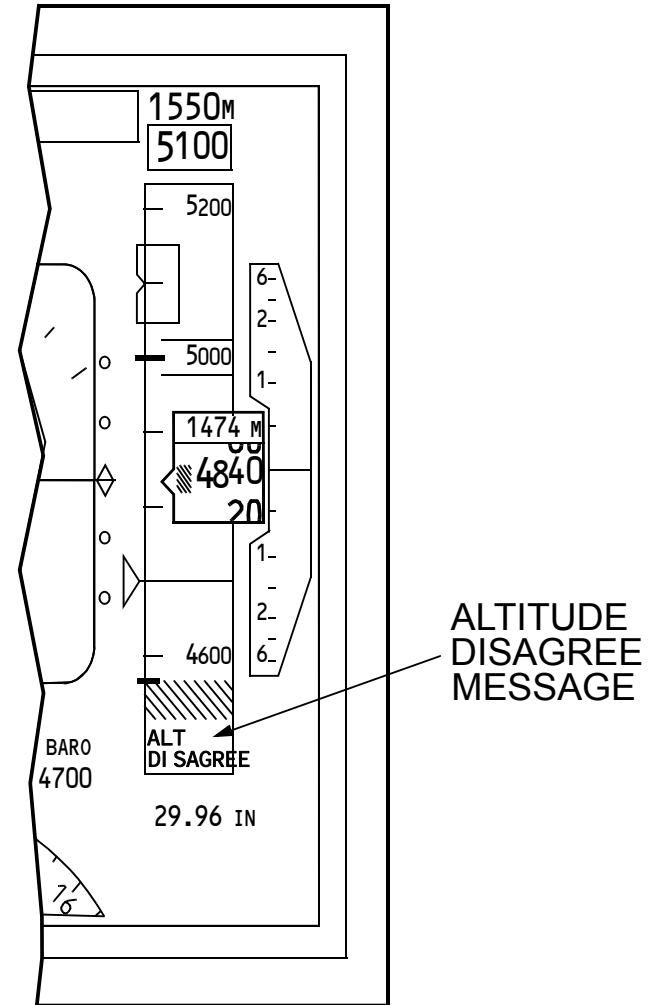
737 NG - ALTITUDE DISAGREE

## ALT DISAGREE Message Possible Causes.

- AOA Sensor
- Pitot leak or blockage
- Static leak or blockage
- Water in pitot or static tubing
- ADIRU
- Pitot or Static ADMs
- EFIS Control Panel
- DEU

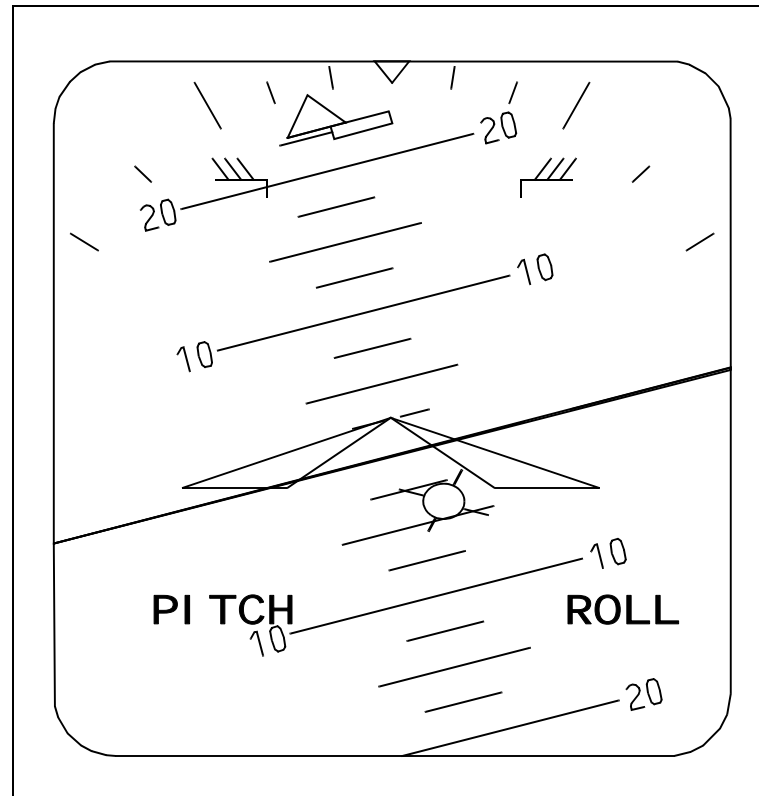
### 737 NG - PITCH & ROLL COMPARATOR ANNUNCIATIONS

### Pitch and Roll Comparator Possible Causes

- ADIRU
- DEU

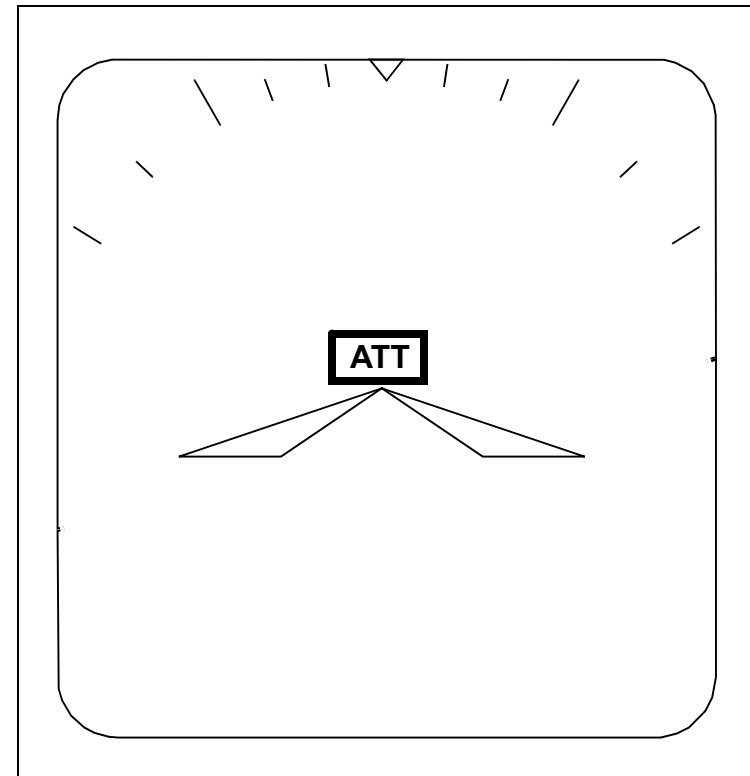
737 NG - ATTITUDE - FLAG

### Attitude (ATT) Fail Flag

The Amber ATT flag replaces the attitude indication.

- ADIRU
- DEU
- Wiring from the ADIRU to the DEUs

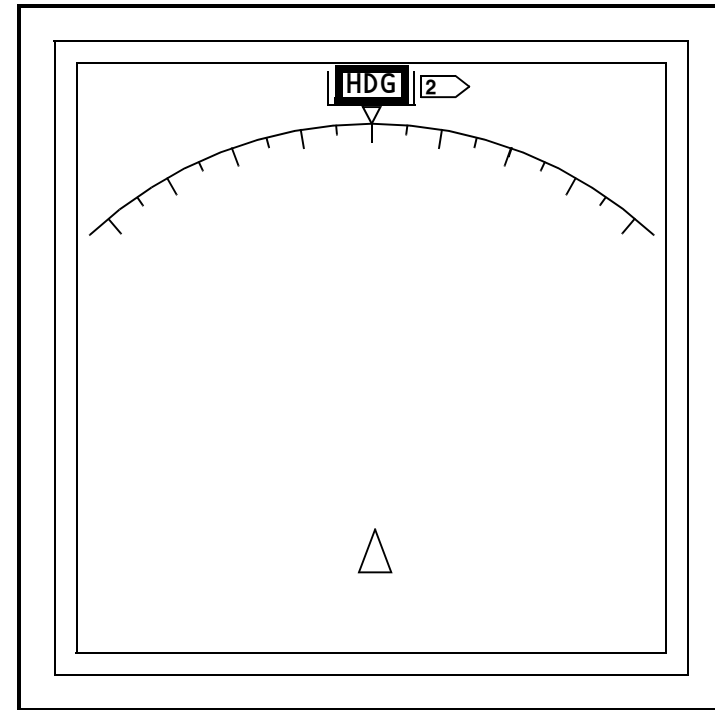
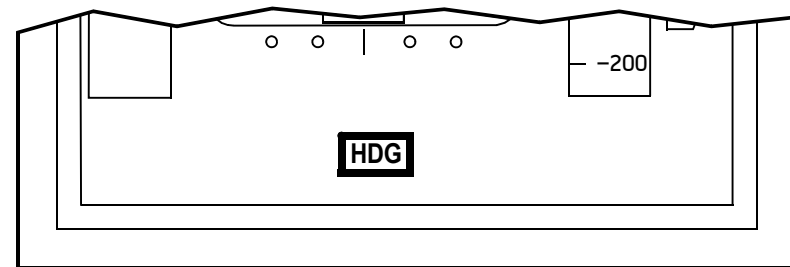
737 NG - HEADING - FLAG

## Heading (HDG) Fail Flag

**NOTE:** If the Nav Data Display is in the MAP mode a TRK fail flag is shown in place of a HDG Flag.

- ADIRU
- DEU
- Wiring from the ADIRU to the DEUs

2 → MAP MODE **TRK**

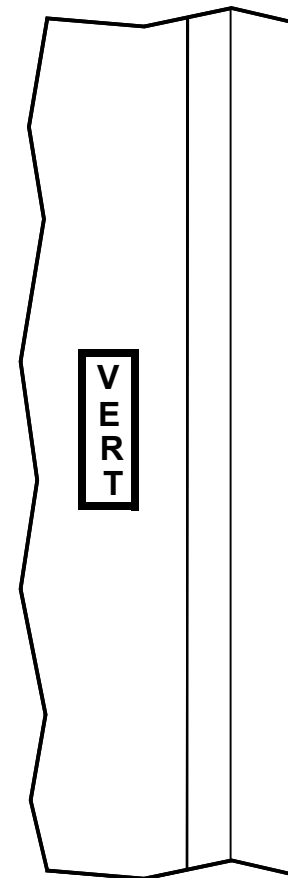
737 NG - VERTICAL SPEED - FLAG

### Vertical Speed Indication (VSI) Fail Flag

- ADIRU
- DEU
- Wiring from the ADIRU to the DEUs
- Wiring (external) from the Air Data side of the ADIRU to the Inertial Reference side

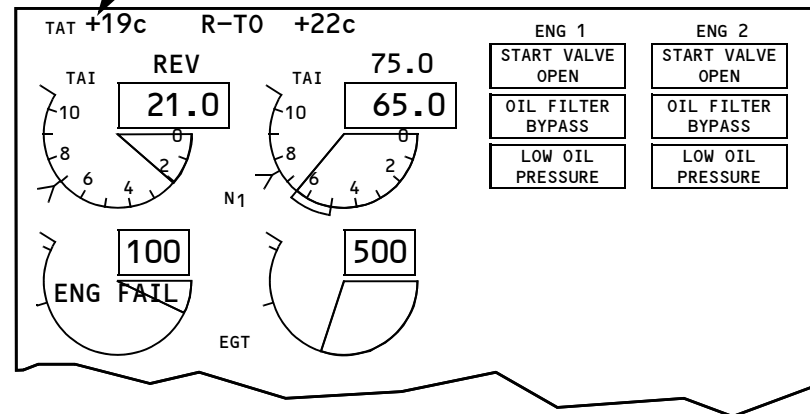
## 737 NG - TOTAL AIR TEMPERATURE - MISSING

## Total Air Temperature (TAT) Missing

**NOTE:** If both elements of the TAT probe fail, and the N1 set knob on the P2 panel is in AUTO, the N1 bugs will dive to zero when the aircraft climbs above field elevation.

## TOTAL AIR TEMPERATURE INDICATION

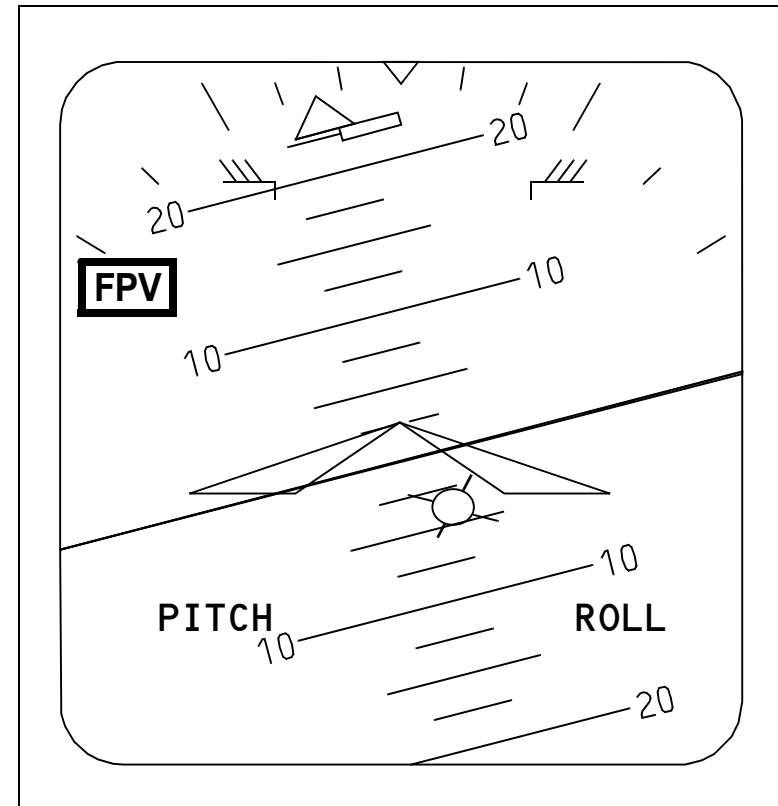
737 NG - FLIGHT PATH VECTOR - FLAG

### Flight Path Vector (FPV) Fail Flag

- ADIRU
- DEU
- Wiring from the ADIRU to the DEUs

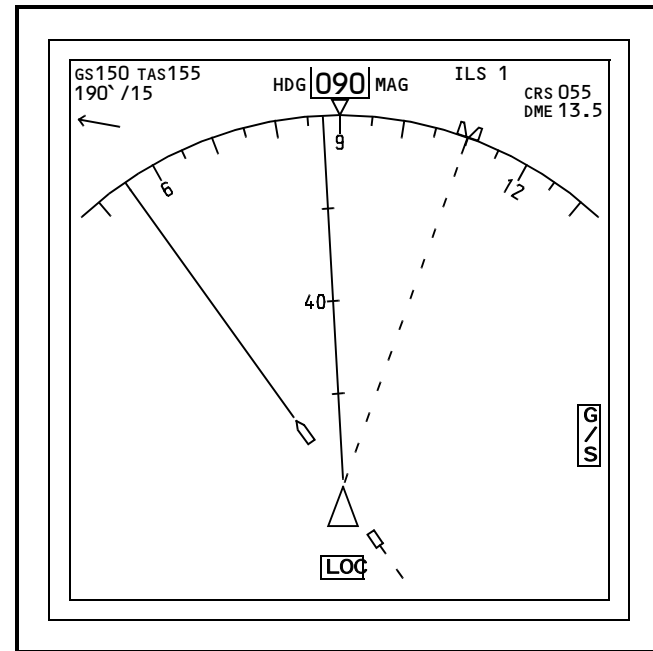
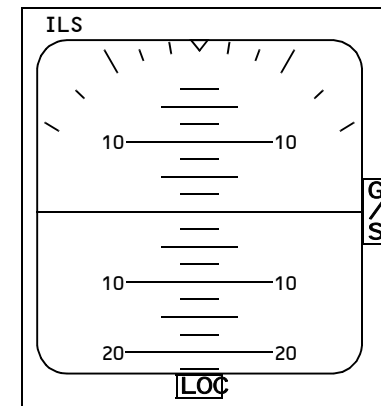
### 737 NG - ILS - GLIDESLOPE & LOCALIZER - FLAG

### Localizer and Glideslope Fail Flags

The amber LOC flag replaces the localizer deviation pointer and scale on the ADI, and Nav Data Display when the localizer receiver function has failed.

The amber G/S flag replaces the glideslope deviation pointer and scale on the ADI, and Nav Data Display when the glideslope receiver function has failed.

- MMR
- Wiring from the MMR to the DEUs

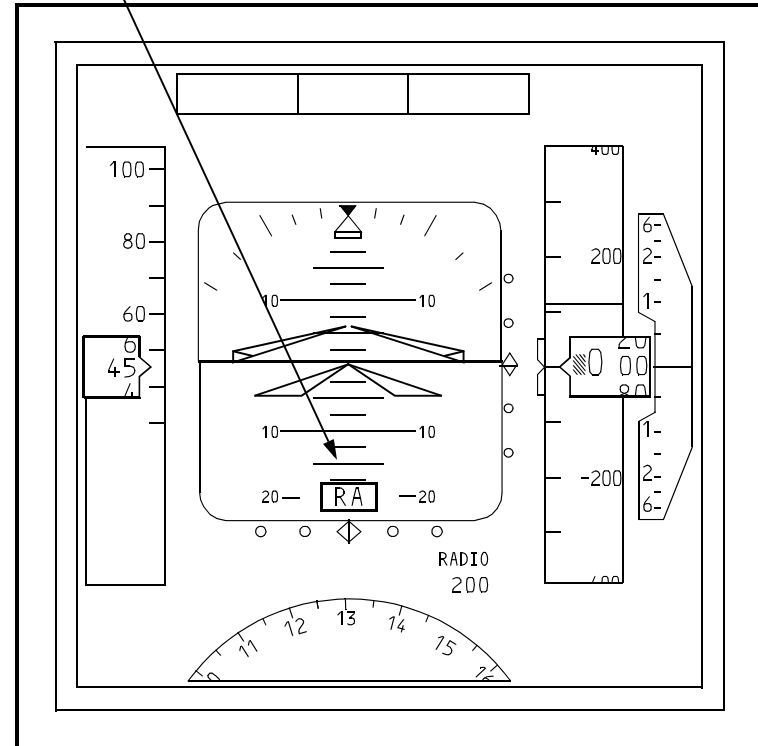
### RADIO ALTIMETER (RA) Fail Flag

Invalid RA data causes an amber RA flag to show in the radio altitude position. Invalid RA also causes the rising runway symbol to be removed. The invalid data occurs when the RA Receiver/Transmitter finds a failure in the RA system.

- RA Receiver/Transmitter
- Antenna
- Wiring from the RA Receiver/Transmitter to the DEUs

RISING RUNWAY  
OUT OF VIEW

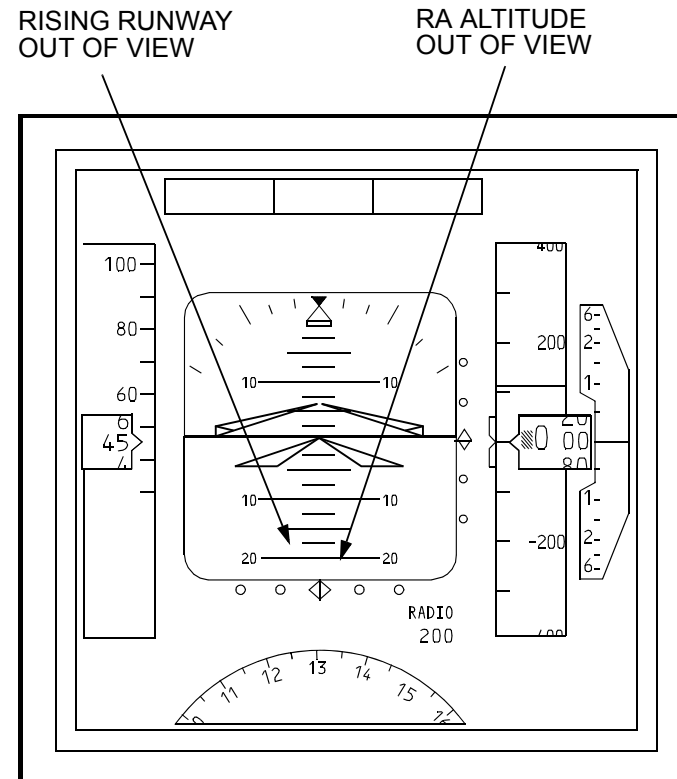
## 737 NG - RADIO ALTITUDE - NO COMPUTER DATA

## Radio Altitude (RA) No Computed Data (NCD)

RA data NCD causes the RA display and rising runway symbol to be removed. The NCD occurs when the return RA signals are too weak or the radio altitude is more than 2500 feet. Also, the rising runway will not show when the ILS is not captured.

- RA Receiver/Transmitter
- Receive Antenna
- Transmit Antenna
- Wiring from the Antennas to the RA Receiver/Transmitter
- Aircraft is 2500 feet or more above the ground

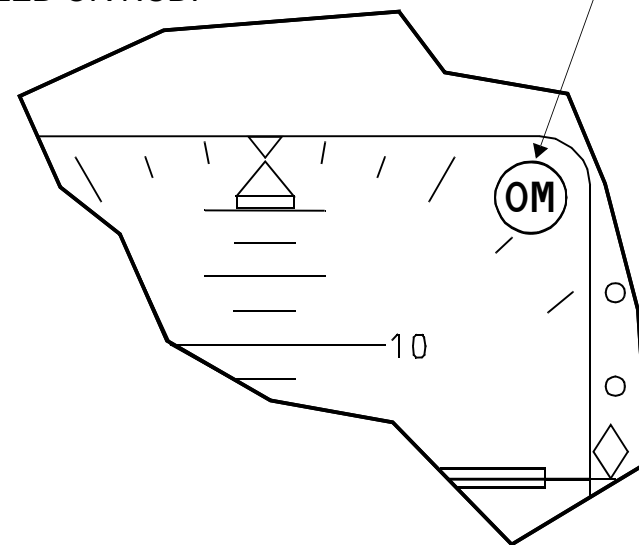
737 NG - MARKER BEACON WILL NOT DISPLAY

If the Marker Beacon data fails or is no computed data (NCD), the display does not display on both the Captain and F/O AI display.

- #1 VOR/MB Receiver
- Remote Electronics Unit (REU)
- Wiring

MARKER BEACON INDICATION IS REMOVED WHEN FAILED OR NCD.

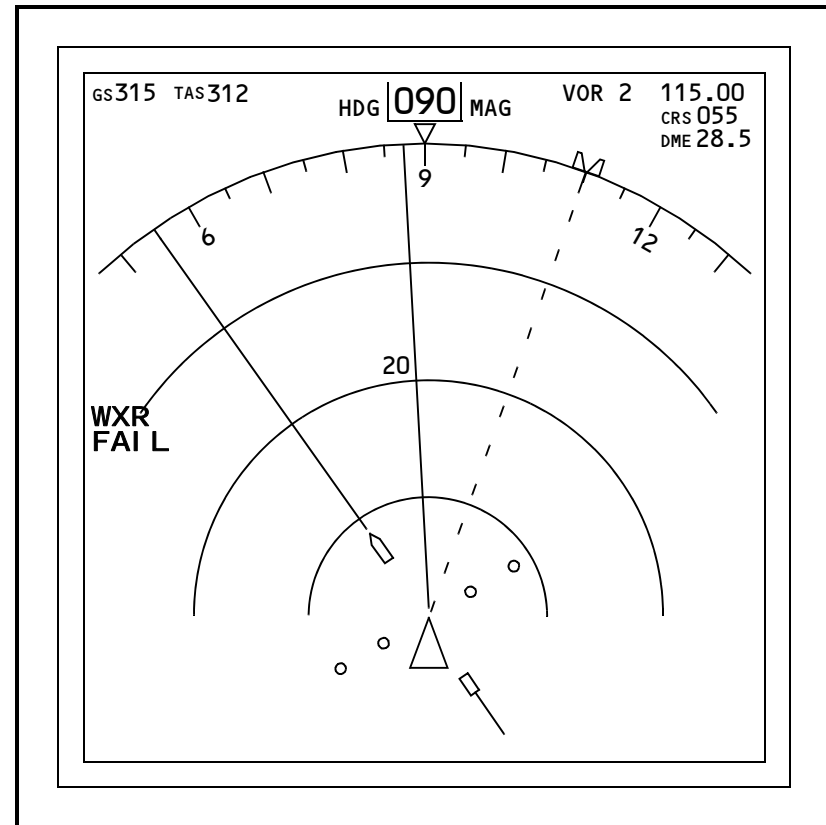
737 NG - WXR FAIL- MESSAGE

## Weather Radar Fail (WXR FAIL) Message

When the Weather Radar fails the amber WXR FAIL shows and all weather displays are removed from the Nav Data Display. WXR FAIL shows in all modes except PLAN.

- WXR Receiver/Transmitter
- WXR Control Panel
- WXR Antenna
- Wiring

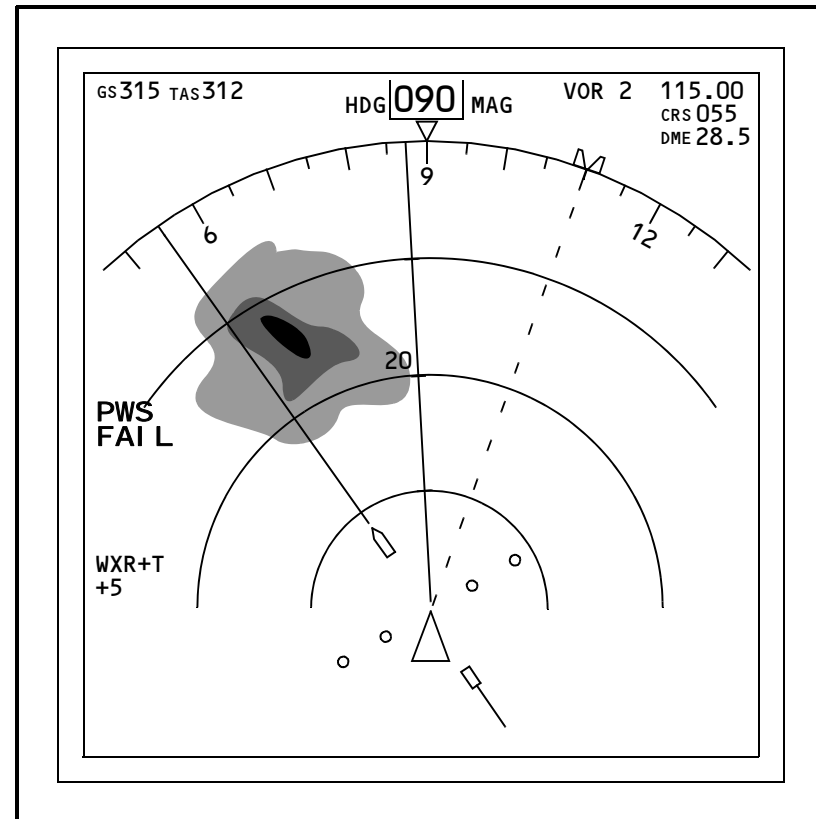
737 NG - PWS FAIL- MESSAGE

### Predictive Windshear Fail (PWS FAIL) Message

When the Weather Radar Predictive Windshear fails the amber PWS FAIL shows in all modes except PLAN. Normal Weather Radar may still operate.

- WXR Receiver/Transmitter
- WXR Antenna
- ADIRU
- Wiring

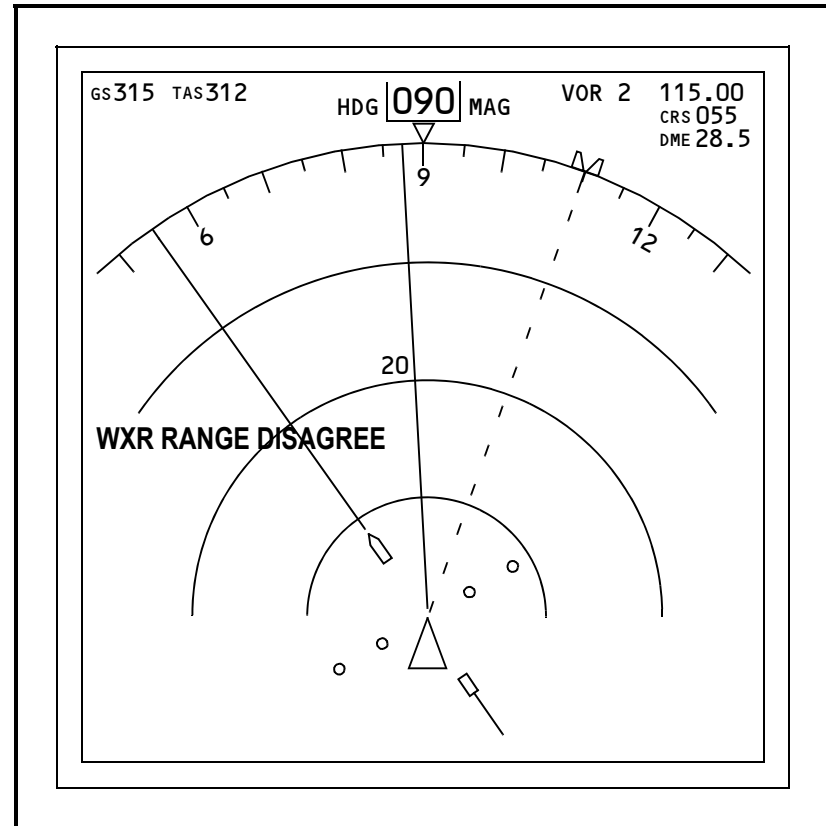
737 NG - WXR RANGE DISAGREE - MESSAGE

### WXR RANGE DISAGREE Message

- EFIS Control Panel
- Weather Radar Transceiver
- DEU
- Wiring

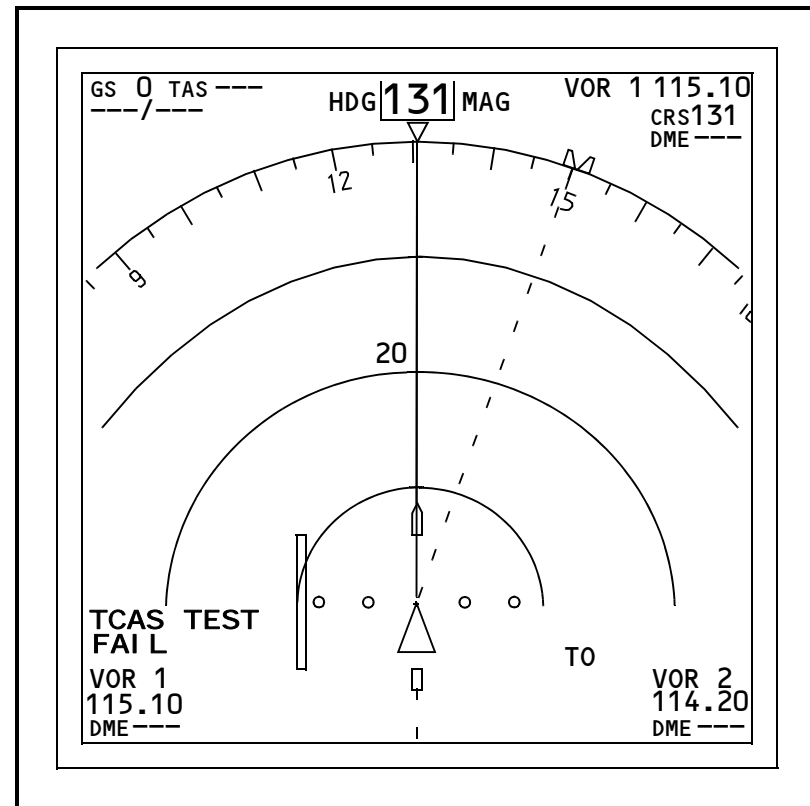
**737 NG - TCAS FAIL - MESSAGE**

## TCAS FAIL Message

The amber TCAS FAIL message indicates a TCAS failure. The message shows in all NAV Data Display modes regardless of whether the TFC button on the EFIS Control Panel is pressed ON or OFF.

The TCAS FAIL message can show for faults that are external to the TCAS Computer as well as for faults that are internal to the TCAS Computer.

When the selected ATC Transponder has failed the TCAS will indicate failure until the alternate operational ATC Transponder is selected

- TCAS Computer
- ATC Transponder
- Antenna
- Wiring

**NOTE:** An air/ground discrete short to ground, or an RA status discrete from the DEUs is grounded, can cause the TCAS FAIL message to show and will not cause a maintenance message on the TCAS Computer.

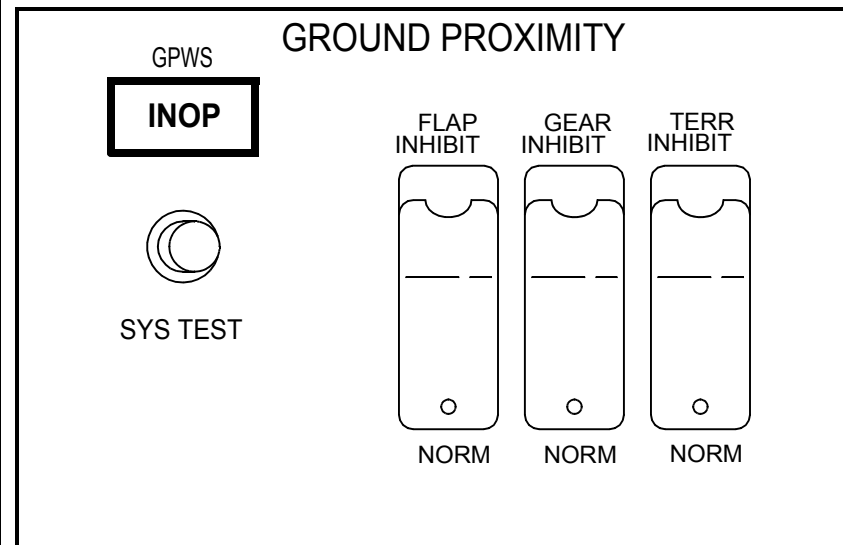
### GPWS INOP Light Possible Causes

**NOTE:** Before replacing the GPWS Computer perform BITE, and check for external faults.

- Ground Proximity Warning Computer
- Wiring

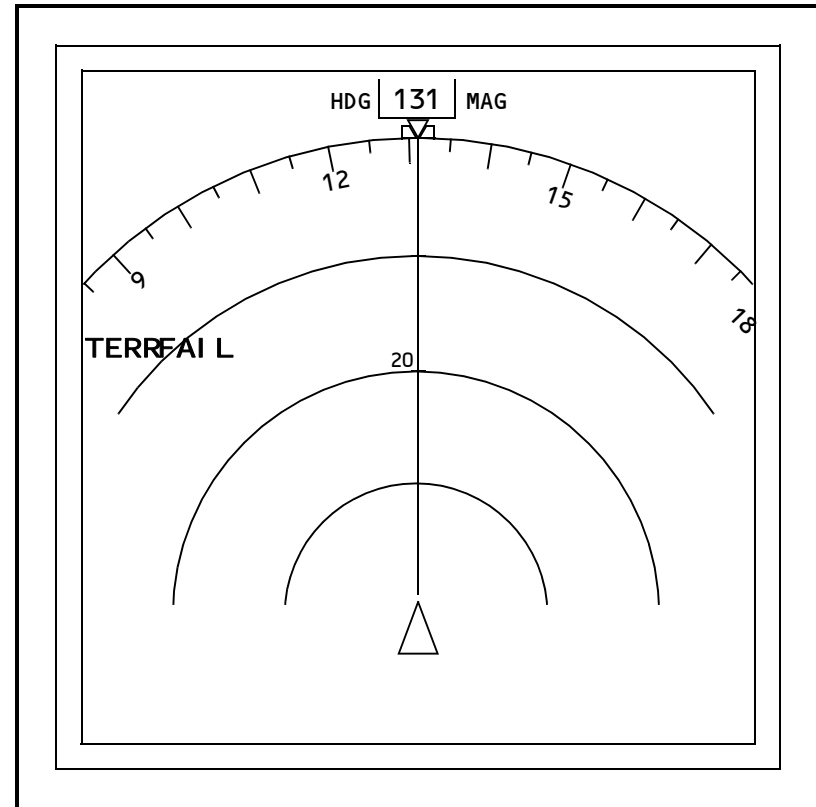
## 737 NG - TERR FAIL - MESSAGE

## EGPWS Terrain Fail (TERR FAIL) Message

The amber TERR FAIL message indicates a failure of the enhanced portion of the Ground Proximity Warning Computer.

The TERR FAIL can temporarily occur in-flight if the aircraft flies into a GPS no-coverage area. (example: White Sands, New Mexico) Check with Dispatch for information concerning GPS no-coverage areas.

TERR FAIL will show if both GPS antennas are not receiving a signal. (example: aircraft in hangar)

- Ground Proximity Warning Computer
- Wiring

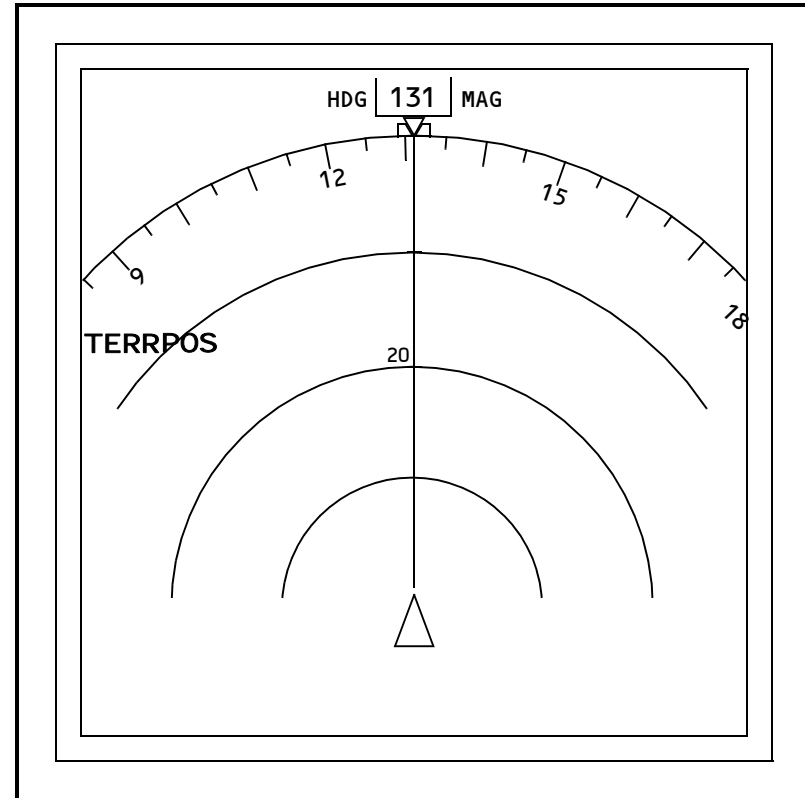
737 NG - TERR POS - MESSAGE

The amber TERR POS message indicates a horizontal position calculation failure of the enhanced portion of the Ground Proximity Warning Computer.

**NOTE:** This message will show if the airplane's GPS antennas do not have a clear view of the GPS satellites.

- Ground Proximity Warning Computer
- Wiring
- Dual MMR GPS function failure

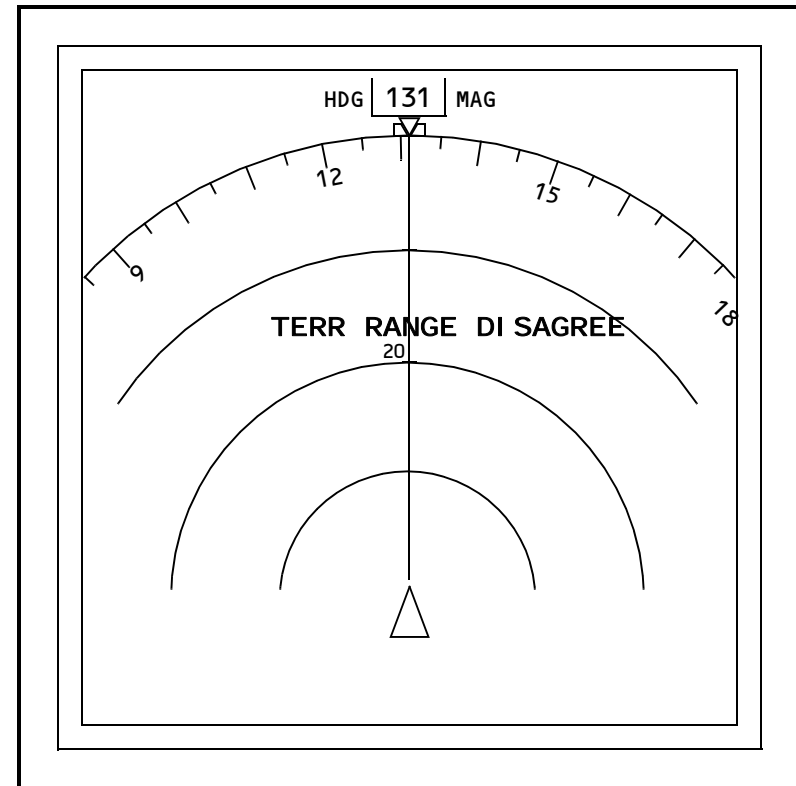
## 737 NG - TERR RANGE DISAGREE - MESSAGE

## TERRAIN RANGE DISAGREE Message Possible Causes

- Ground Proximity Warning Computer (GPWC)
- EFIS Control Panel
- DEU
- Wiring

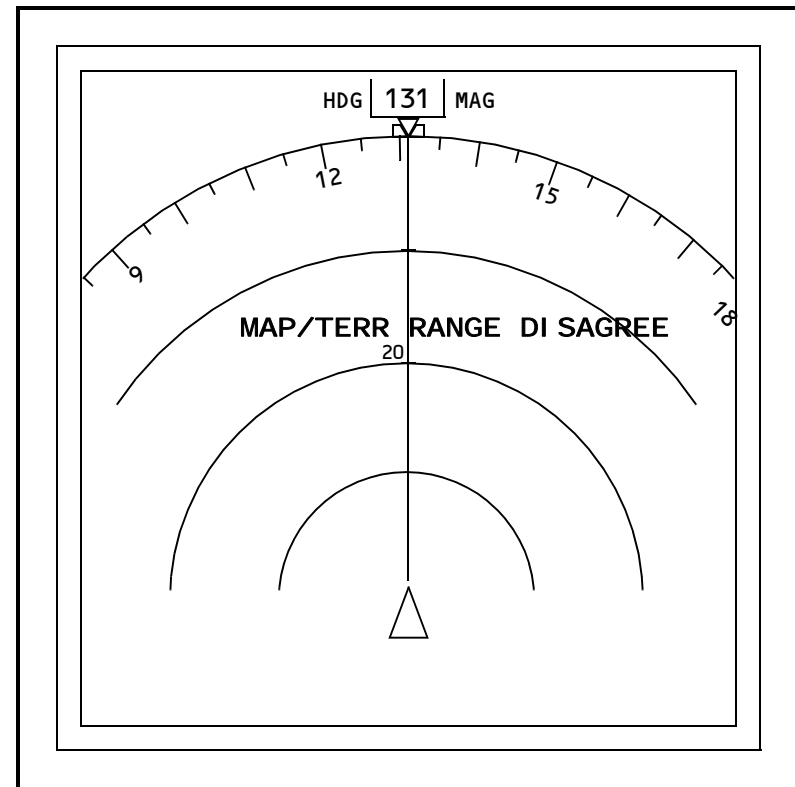
## 737 NG - MAP/TERR RANGE DISAGREE - MESSAGE

## MAP/TERR RANGE DISAGREE Message Possible Causes

- Ground Proximity Warning Computer (GPWC)
- Flight Management Computer (FMC)
- EFIS Control Panel
- DEU
- Wiring
