# B737 NG

## AVIONICS FLAGS / FAULT MESSAGE GUIDE

FOR TRAINING USE ONLY  
PREPARED BY MAINTENANCE TRAINING

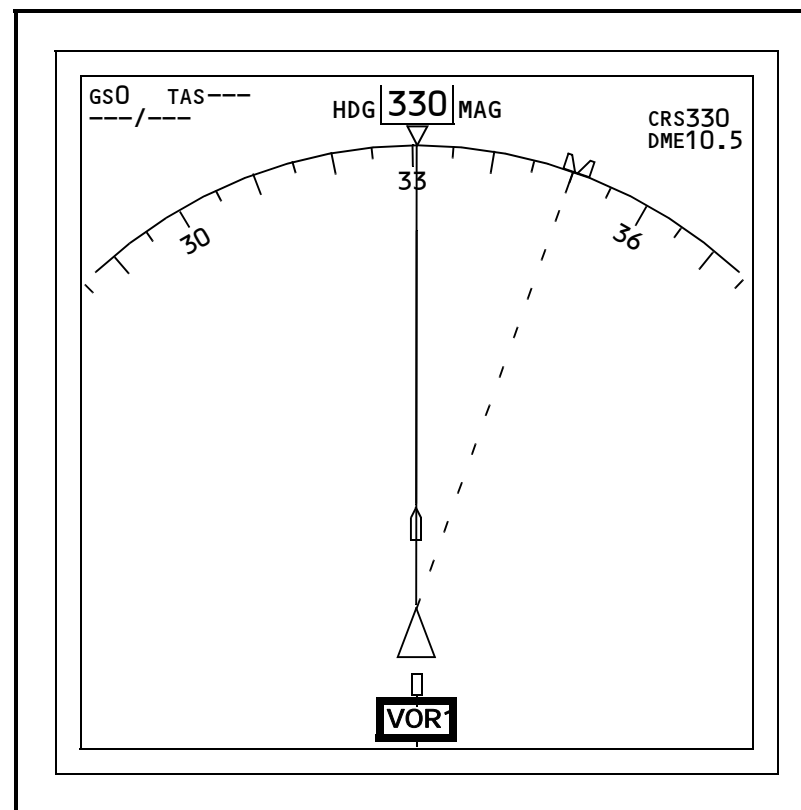
737 NG - VOR - FLAG

## VOR Fail Flags

The Amber VOR flag replaces the VOR deviation pointer and scale on the Nav Data Display. Also, the TO/FROM indicator and VOR frequency is removed from the Nav Data Display. The Nav Data Display must be set to VOR for the VOR flag to display.

- VOR Receiver
- Wiring from VOR receiver to the DEUs

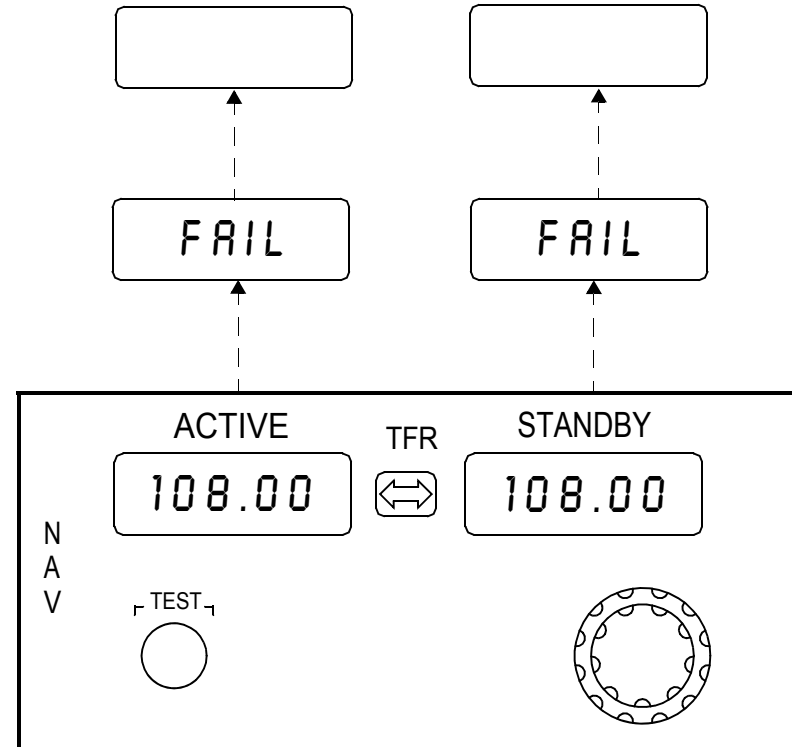
## 737 NG NAVIGATION CONTROL PANEL FAILURE

## NAV Control Panel FAIL

The Nav control panel continuous bite monitors the control panel operation. The NAV control panel shows FAIL in the active and standby window when a failure is detected or the panel loses its 115V AC power.

## NAV Control Panel Faults Possible Causes

- NAV Control Panel
- 115V AC power (C/B or wiring)
- 28V DC power. ( C/B or wiring)

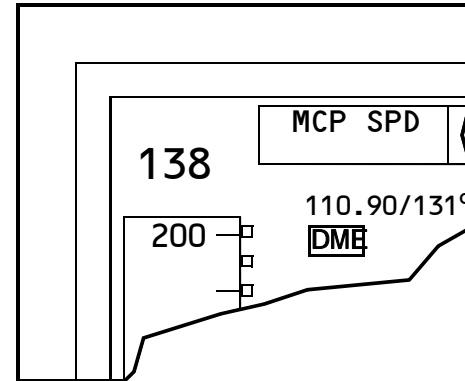
DME FAILURE INDICATION ON PFD

The amber DME flag replaces the DME distance reading on the Nav Data Display and Primary Flight Display.

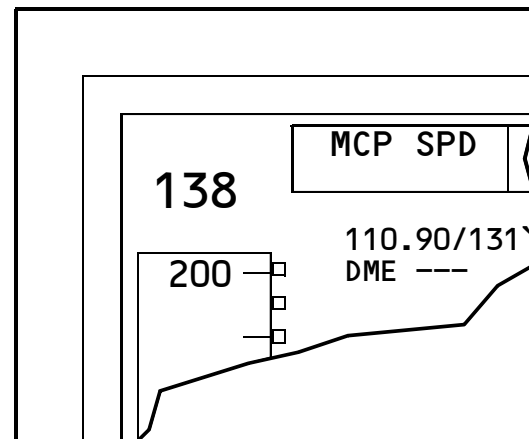
DME NCD INDICATOIN ON PFD

DME distance is removed and replaced by dashes. The dashes show on the Primary Flight Display and the Nav Data Display.

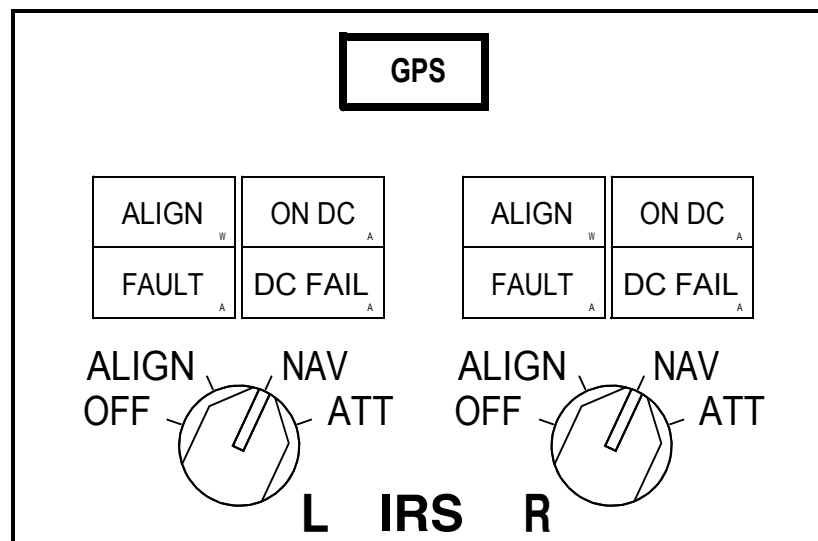
### 737 NG - GPS FAIL - LIGHT

## Global Position System (GPS) Fail Light

The GPS has continuous monitor BITE. These are the three ways to detect GPS failures:

- When both GPS system 1 and 2 fail, the amber GPS fail light comes on automatically
- With a single GPS failure, recall must be activated to illuminate the GPS fail light
- The FMC SENSOR STATUS page shows MMR failures. The FMC SENSOR DATA page shows the internal failure in the MMR

- Multimode Receive (MMR)
- GPS Antenna
- Wiring

**NOTE:** If the flight crew reports a loss of GPS position left and/or right on the FMC POS REF page of the MCDU, with no GPS fail light, perform BITE on the MMR(s). If MMR passes BITE, then replace the GPS antenna on the side that is not showing GPS position.

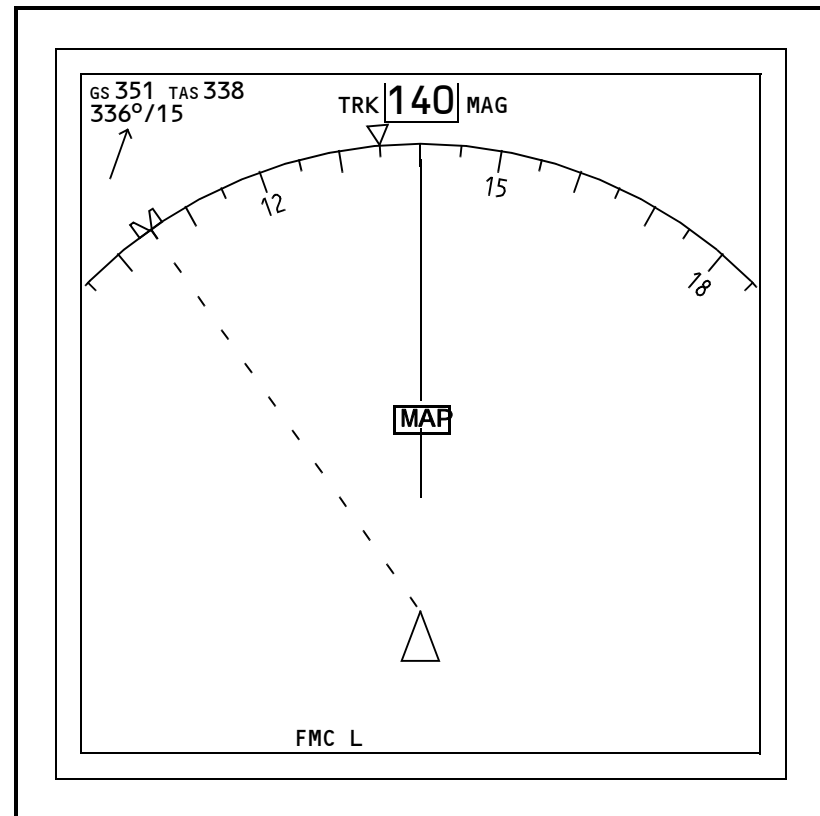
737 NG - MAP - FLAG

### MAP Fail Flag

The amber MAP flag shows if the map data from the Flight Management Computer (FMC) is invalid. All map data is blanked in this condition. The aircraft symbol, track line, heading select bug, compass rose, GS, TAS, wind direction and speed from the ADIRU will be valid and shown.

- Flight Management Computer (FMC)
- Wiring.
- Toggling the FMC selector to BOTH on 1 then BOTH on 2, back to NORMAL

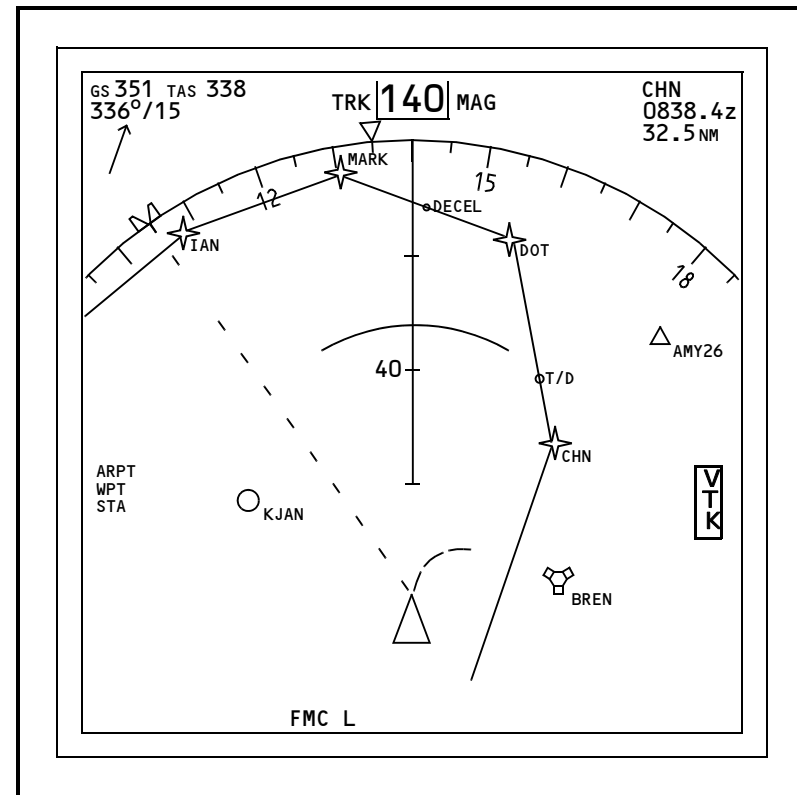
737 NG - VERTICAL TRACK - FLAG

## Vertical Track (VTK) Flag

The amber VTK flag shows when the vertical deviation data from the Flight Management Computer (FMC) invalid. Only the vertical deviation scale is blanked in this condition.

- Flight Management Computer (FMC).
- Toggle the FMC selector to BOTH on 1 then BOTH on 2, back to NORMAL

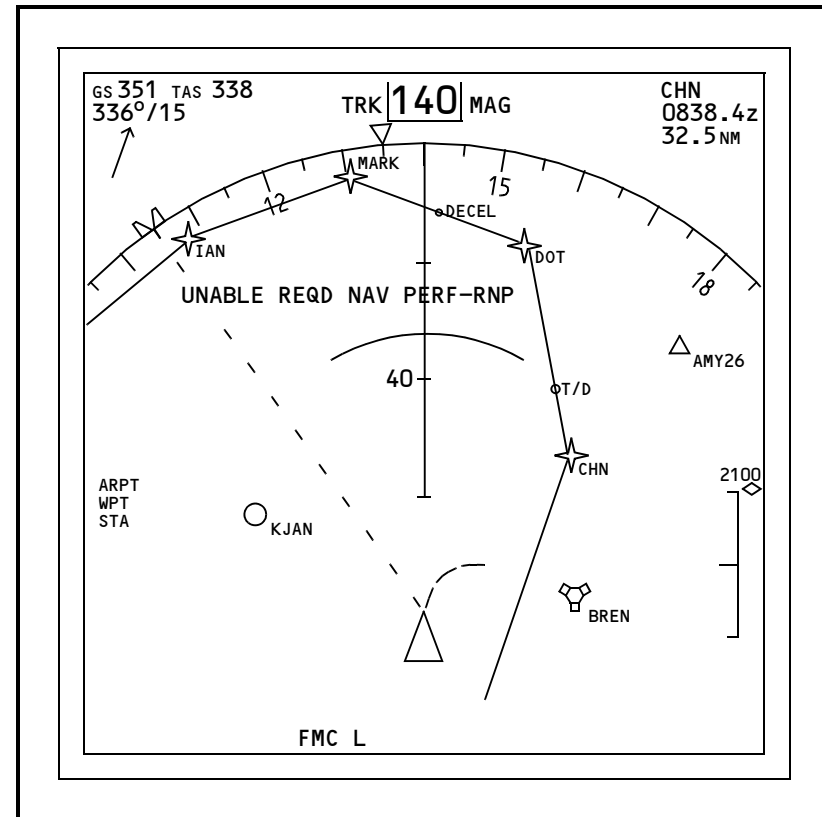
## 737 NG - UNABLE REQD NAV PERF - RNP - MESSAGE

The UNABLE REQD NAV PERF - RNP message shows when the Actual Navigation Performance (ANP) exceeds the Required Navigation Performance (RNP) for the current flight environment. The map data is not blanked in this condition. The flight crew must select a reliable navigation source from the FMC. Check POS SHIFT page for corrupted data. Update with the best NAV sensor data values GPS, DME, or VOR via the MCDU.

- Flight Management Computer (FMC)
- Toggle the FMC selector to BOTH on 1 then BOTH on 2, back to NORMAL

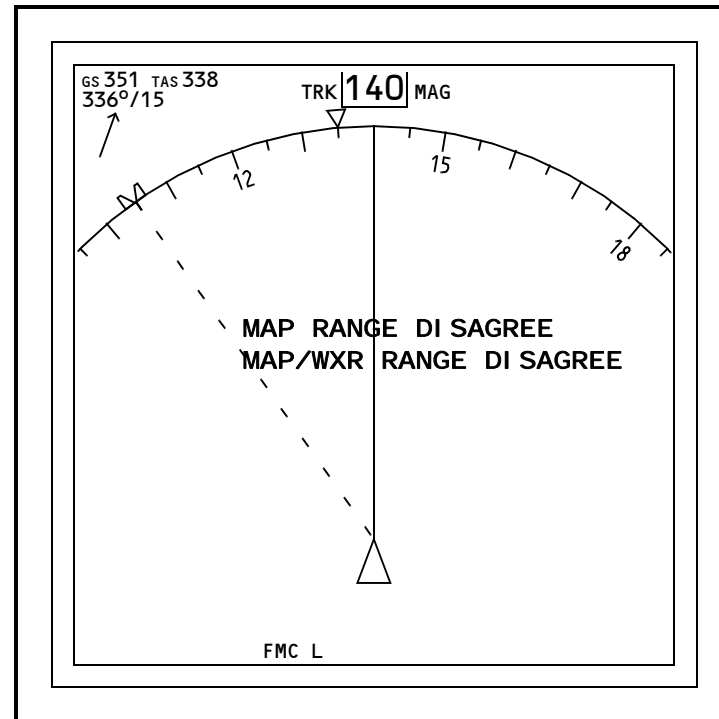
**737 NG - MAP RANGE DISAGREE - MESSAGE**

The Amber MAP RANGE DISAGREE message shows when a new range has been selected on the EFIS control panel and new map data is not received from the FMC. All map data is blanked in this condition. The display will default to the 40 mile range, and the aircraft symbol, track line, heading select bug, compass rose, GS, TAS, wind direction and speed from the ADIRU will be shown.

**MAP RANGE & MAP/WXR DISAGREE Message Possible Causes**

- EFIS Control Panel
- Flight Management Computer (FMC)
- Weather Radar Transceiver
- DEU
- Wiring

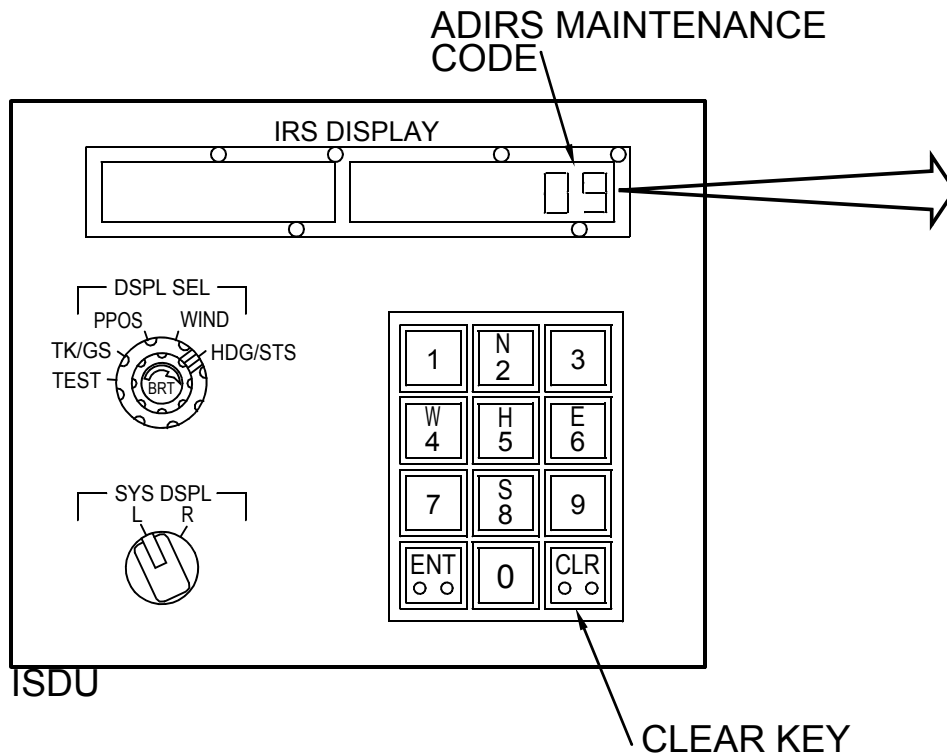
ADIRS maintenance codes show on the IRS DISPLAY of the ISDU. Some codes give the condition of ADIRS components and signals. Some codes give instructions.

Two or more codes cause the ISDU CLR key light to come on. Push the CLR key to show the codes in sequence.

You can see the list of ADIRS maintenance codes on the MCDU. The list is a part of the ADIRS BITE.

CODE TABLE	
01	ISDU FAIL
02	IR FAILURE
03	EXCESSIVE MOTION
04	ALIGN FAULT
07	ADR DATA INVLD
08	ENTER PPOS
09	ENTER HEADING
10	ISDU POWER LOSS
18	NO ADR DATA
19	IR PROG PIN INVLD
20	ADR FAIL
21	ADR PROG PIN INVLD
22	TAT PROBE SIGNAL FAIL
23	AOA SIGNAL FAIL
24	NO AOA REF SIGNAL
1	26 NO BARO 3 REF SIGNAL
27	NO PITOT ADM DATA
28	NO STATIC ADM DATA
29	NO BARO 1 DATA
30	NO BARO 2 DATA
31	NO IR DATA
32	PITOT ADM DATA INVLD
33	STATIC ADM DATA INVLD
34	BARO 1 DATA INVLD
35	BARO 2 DATA INVLD
1	36 BARO 3 SIGNAL FAIL
37	IR DATA INVLD
38	AIR/GND LOGIC INVLD
